Site HCMB 19B: St Croix River (Hwy 101)

Date Assessed: 04/09/03, 05/12/03

Crossing Status: No restriction.

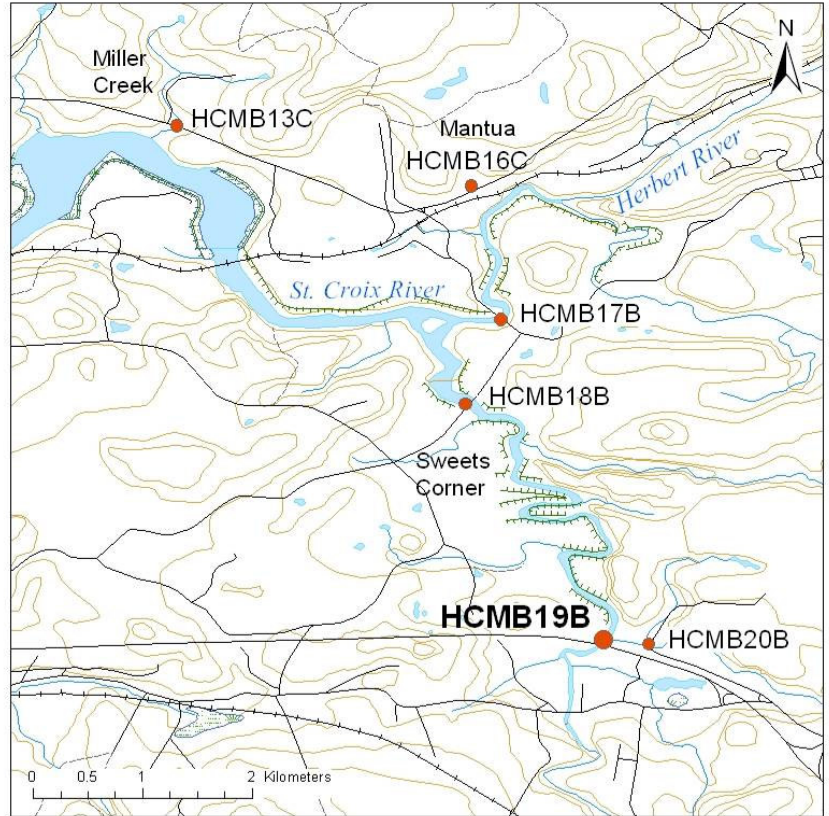
Comments: Large bridge, reaching bank to bank with large support structures in middle of channel. Crossing planned to be replaced by divided highway. When replacing, new crossing should continue non restrictive trend, but with no support structure(s) in the channel. Be conscious of river meander pattern.
