**Site HCMB 20B:** St. Croix River (dirt road off Hwy 101) **Date Assessed:** 04/09/03,  
05/12/03

**Road Crossing:** 8m long wooden bridge. Does not appear to be DOTPW roadway.

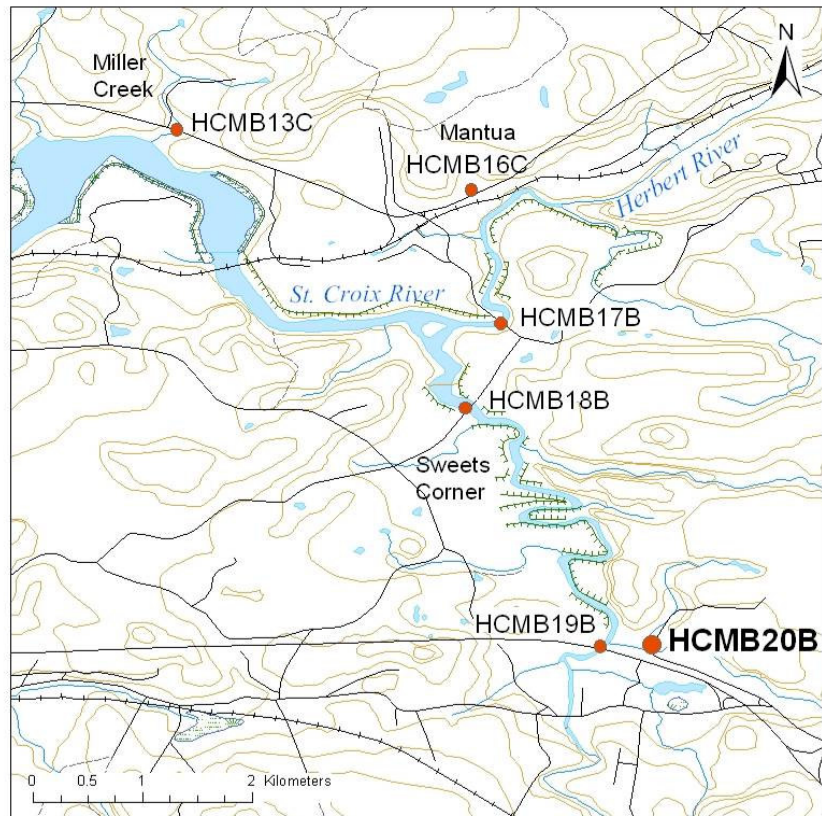
**Creek:** 11m wide creek with no apparent bank slumping or erosion, and mostly a smooth flow. Bank edges approaching either end of bridge re-enforced with timbers.
