Site KCMB 14C: Kingsport Marsh 2

Date Assessed: 03/08/04

Road Crossing: Two chambered wooden box culvert

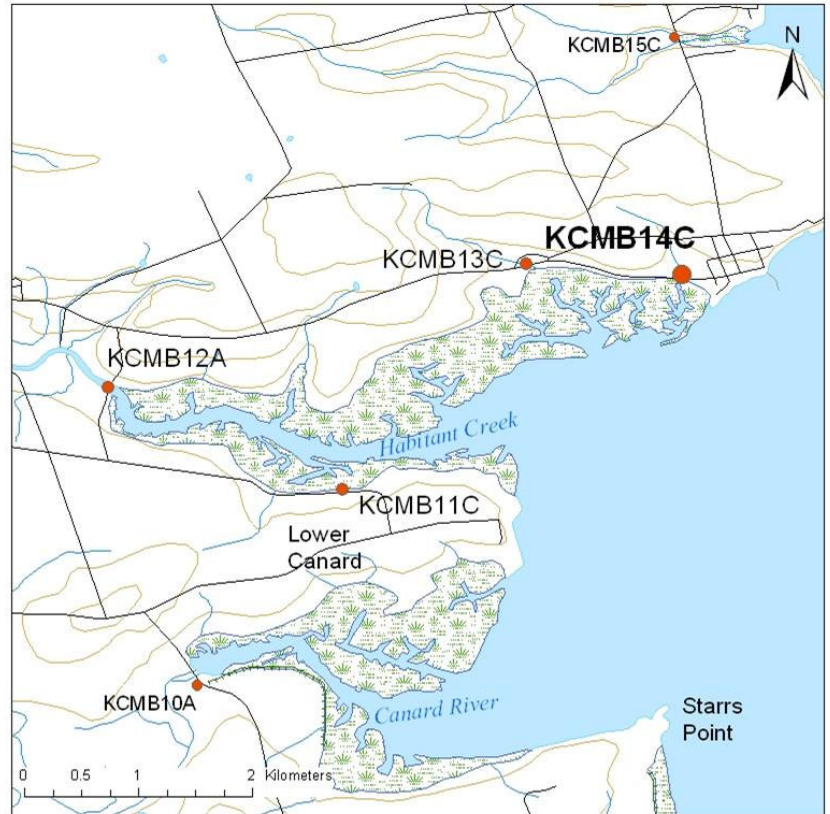
Crossing Condition: Crossing is in considerable state of disrepair. Structure is damaged at both ends, and internally is partially blocked by debris.

Comments: Culvert is old, severely damaged and is a significant tidal restriction. A larger opening would improve tidal flow, fish passage and upstream habitat conditions.
