Site KCMB 17C: Pereaux culvert 1

Date Assessed: 03/08/04

Road Crossing: 1m wooden box culvert

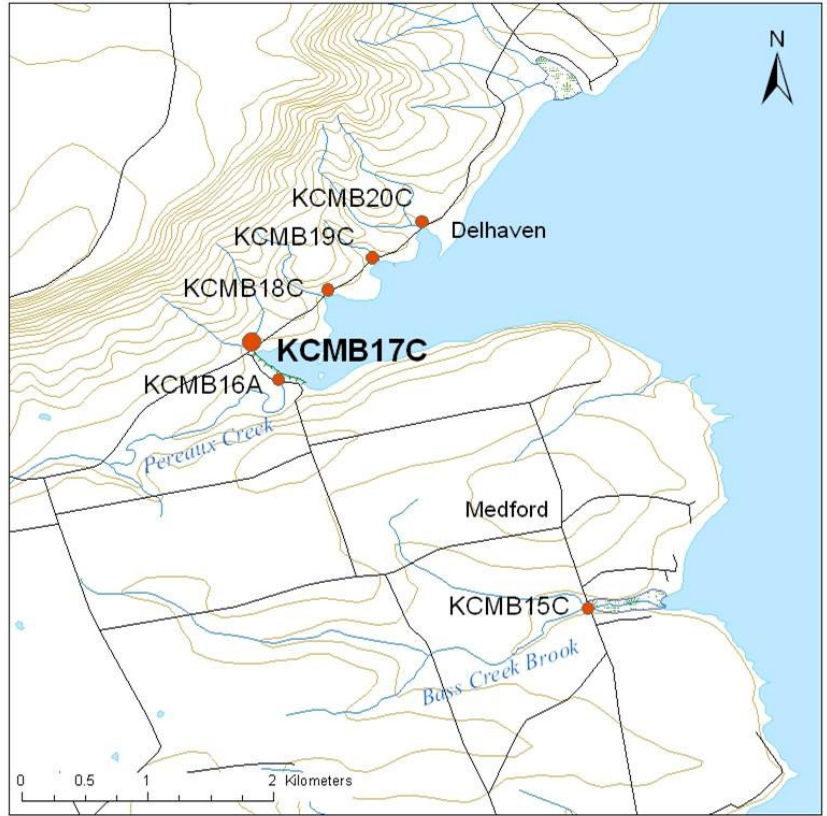
Figure 1. Culvert upstream

Crossing Condition: Damaged at both ends, collapsing and partially blocked by debris

Comments: Culvert is in need of repair/replacement and although a larger opening would improve flow, the wetland area upstream is small and not able to expand due to rise in elevation.
