Site KCMB 4B: Wallbrook

Date Assessed: 04/09/03, 05/12/03

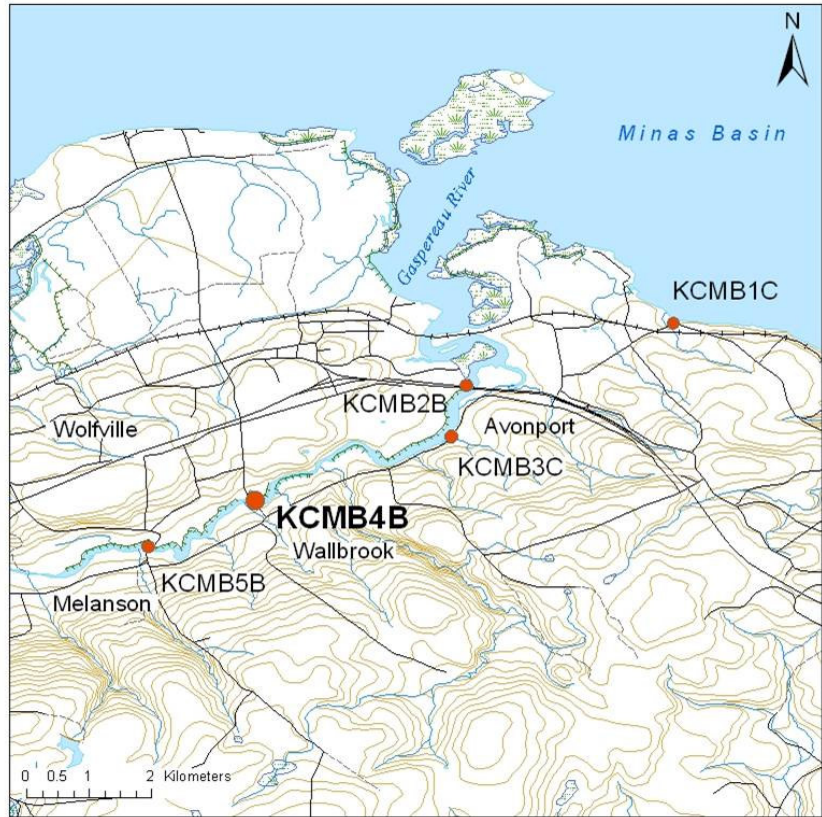
Comments: Bridge spans the main river channel and creates very little obstruction to tidal flow. Adjacent lands are dyked and appear to be actively farmed. .

Figure 1. Full view of the bridge.
