**Site KCMB 7C:** Kentville

**Date Assessed:** 04/09/03, 05/12/03

**Crossing Status:** No longer tidal

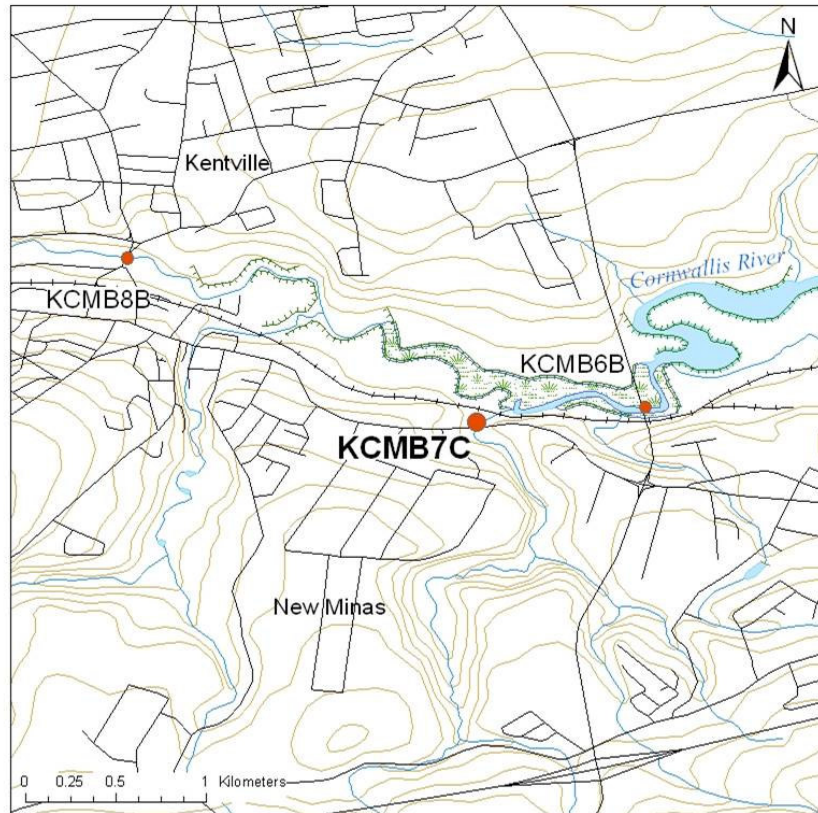
**Crossing Condition:** Lower culvert is collapsing and partially blocked (downstream) by rock and woody debris. The smaller, higher culvert appears newer and in good condition.

**Figure 1.** The culvert and drainage pipe.
