**Tidal Barriers & Opportunities for
Salt Marsh and Tidal River Restoration in the
Southern Bight of the Minas Basin, Nova Scotia**

By Nicole Hynes, Tony Bowron,
and Dawn-Marie Duffy

April 2005

Coastal Issues Committee Special Publication # 4
Ecology Action Centre

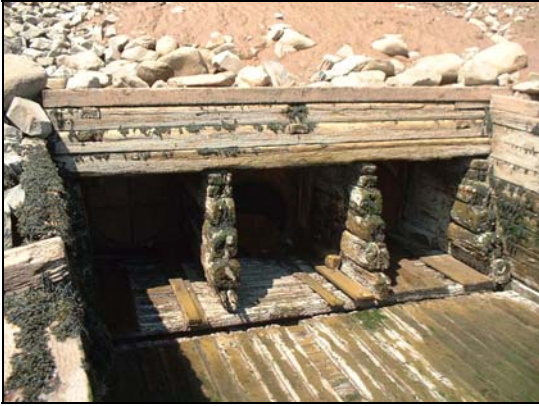
Figure 8. Downstream view of crossing

Comments: The limited restoration of tidal flow to the system due to the failure of the aboiteau does not appear to have adversely affected upstream infrastructure or land use, but should be reviewed in greater detail than allowed by this audit. At a minimum, the broken gates should be removed to allow increased flow and fish passage. Full restoration of tidal flow and fish passage could be achieved by replacing the entire structure with a crossing designed to better mimic natural conditions. However, upstream land use and additional road and highway crossings should be assessed for potential impact.

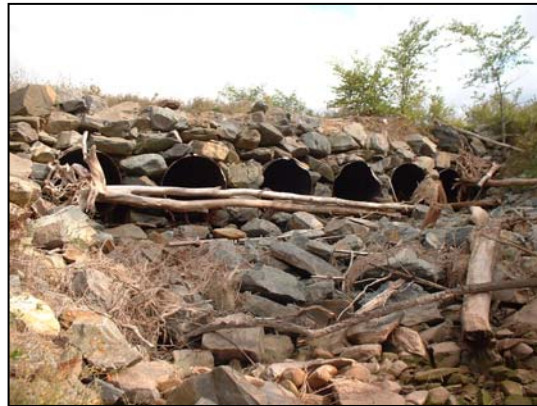
Figure 11. Upstream view of the six overflow aboiteaux.

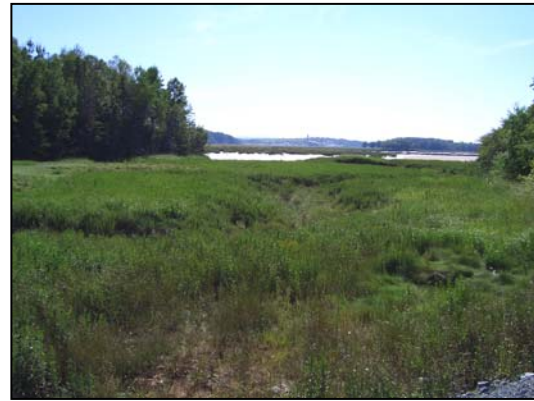
Figure 21. Downstream view of crossing

Comments: At the time of assessment, the site showed evidence of recent maintenance work, potentially the installation of the two culverts, excavation of the creek channel to match culvert placements, and the resurfacing of the roadside and slope. The wetland system downstream is dominated by tidal and freshwater wetland vegetation while the upland wetland system is mainly freshwater vegetation. Area upstream is small in size and unlikely to increase in area with the installation of a larger crossing. However, the installation of a single, large opening would improve hydrology at the site.

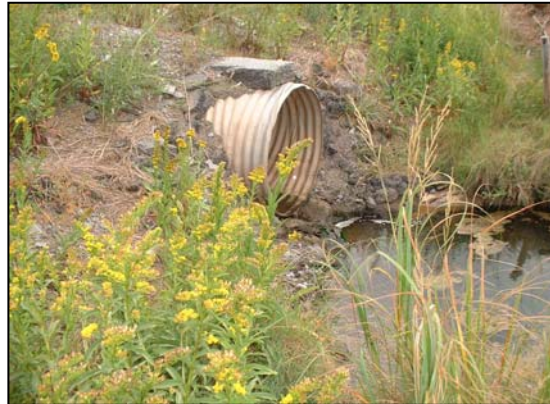
Comments: The road is built along the upland edge of a large tidal marsh that appears to be in use as agricultural grazing land. The culvert drains a small wetland upstream of the road (and upland agricultural area). A larger culvert, set flush with the creek bed would improve tidal exchange and drainage of upland, but the potential for restoring/increasing wetland habitat at this location is low.

Figure 22. Upstream view of culvert

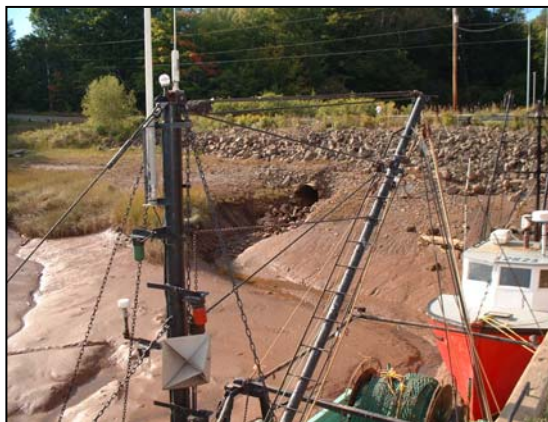
Comments: Road was constructed along the inner edge of the harbour and culvert functions mainly to allow drainage of the upland system. Replacing the culvert with

Figure 25. Downstream of crossing at low tide

a larger structure would improve hydrology at the site but would not result in significant increases/improvements in wetland habitat as the upstream system has no room to expand due to elevation. Site has little opportunity for upstream salt marsh habitat restoration. Enlarging this opening may allow more tidal water to move upstream beyond the road and provide greater flow capacity on ebb tide to naturally dredge the downstream harbour.

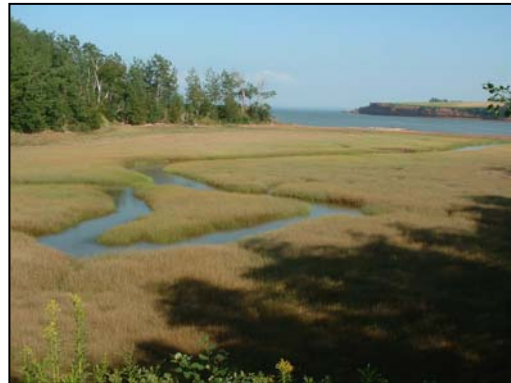
Comments: Road is built near the upland edge of the inlet and although the culvert is a restriction to tidal flow and fish passage, the size and structure of the upland system minimizes the impact. While replacement of the culvert with a larger opening would improve hydrology, it would not result in significant improvements in habitat conditions.

Figure 26. Downstream of crossing at low tide.

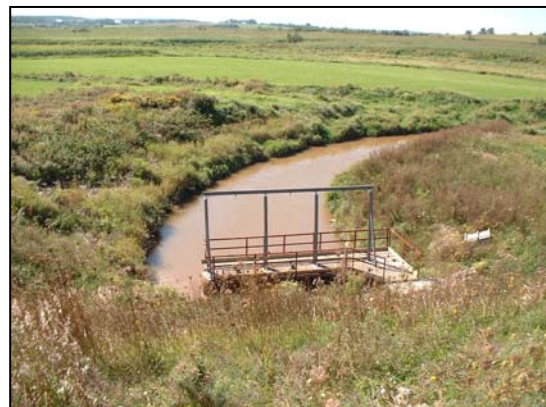
Comments: The roadway crosses over the top of the Wellington Dyke which contains an aboiteau near the mouth of the Canard River. A mile long dyke and aboiteaux was originally constructed across the mouth of the Canard River in 1823 after seven years of construction (Department of Agriculture and Marketing 1987). The current dyke and aboiteau which protects some 3030 acres of former tidal wetland was completed in the early 1970's and was built in 'the dry' upstream of the original dyke (Department of Agriculture and Marketing 1987). Sections of the downstream salt marsh continue to have large sections of the former marsh protected behind dykes. Given the continued value of the agricultural lands upstream of the Wellington Dyke, restoration of tidal flow and salt marsh habitat in the foreseeable future is unlikely, however, fish passage over or

Figure 32. Upstream agricultural lands protected by the Wellington Dyke and Aboiteau.

through the barrier should be examined.

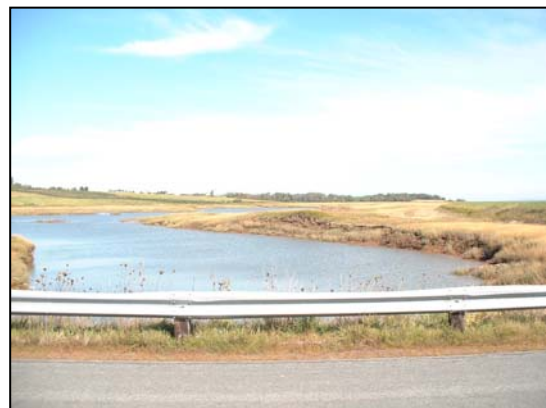
Figure 33. Lower Canard River and salt marsh system. Photograph taken from the road surface above the aboiteau.

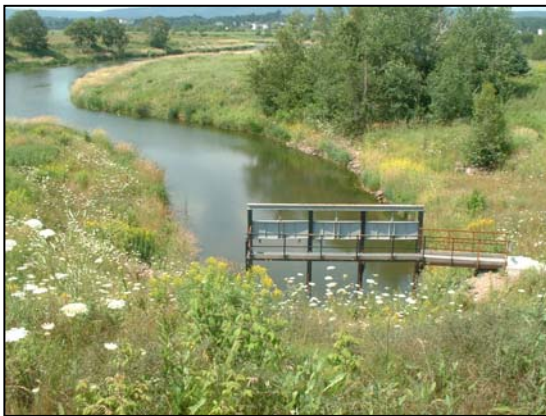
Comments: Similar in history to the Wellington Dyke, the dyke and aboiteau across the Habitant River as it is seen today, was constructed in the late 1970's and protects a considerable amount former tidal wetland habitat for a variety of land use activities. Given the continued use of the lands upstream of the dyke, partial or complete restoration of tidal flow to the Habitant River is not an option at this time; however, fish passage through the barrier should be examined. An extensive salt marsh system is present downstream of the dyke.

Figure 34. Upstream end of the Habitant River Aboiteau.

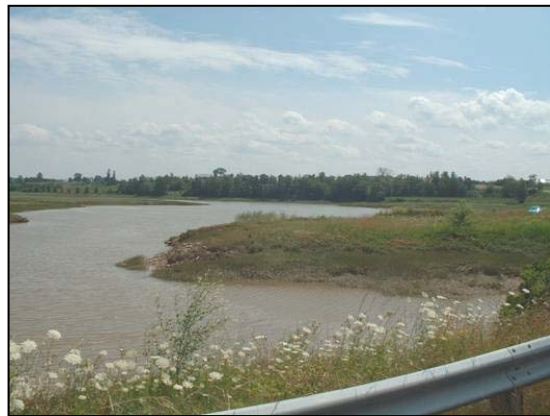
Figure 35. Downstream of aboiteau on a mid-low tide.

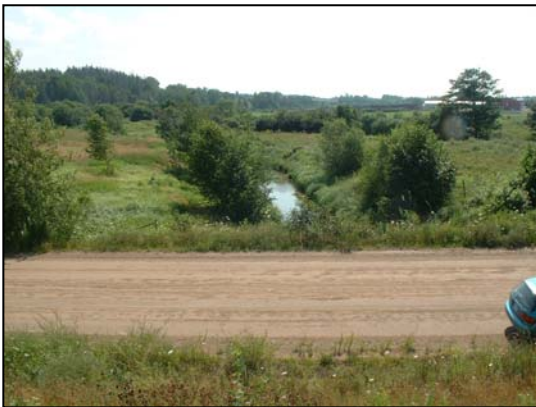
Comments: This is a large modern dyke and aboiteau structure crossing near the mouth of the Pereaux River. A dirt road runs immediately upstream of the dyke and shares the aboiteau. Land immediately upstream is fallow with the dominant vegetation being shrubs, bushes and trees. The potential for the restoration of tidal flow and tidal wetland habitat to this system at the present time is low due the continued agricultural use of the lands further upstream, however, fish passage over or through the barrier should be examined.

Figure 36. Photo taken from top of the dyke looking upstream. The dirt road and fallow upstream lands are visible.

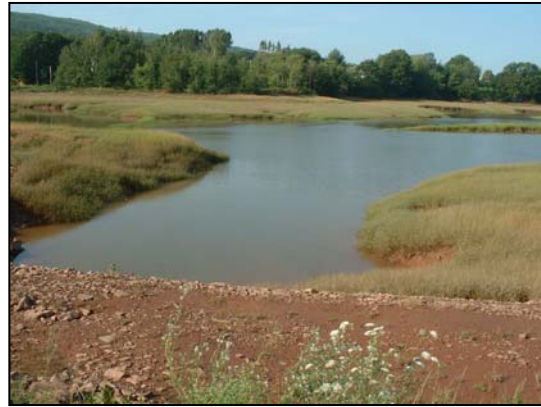
Figure 37. Downstream of aboiteau at mid tide. A portion of the downstream salt marsh system is visible.
