Site N13A: Moose Cove

Road Crossing: Aboiteau
(concrete/wood)

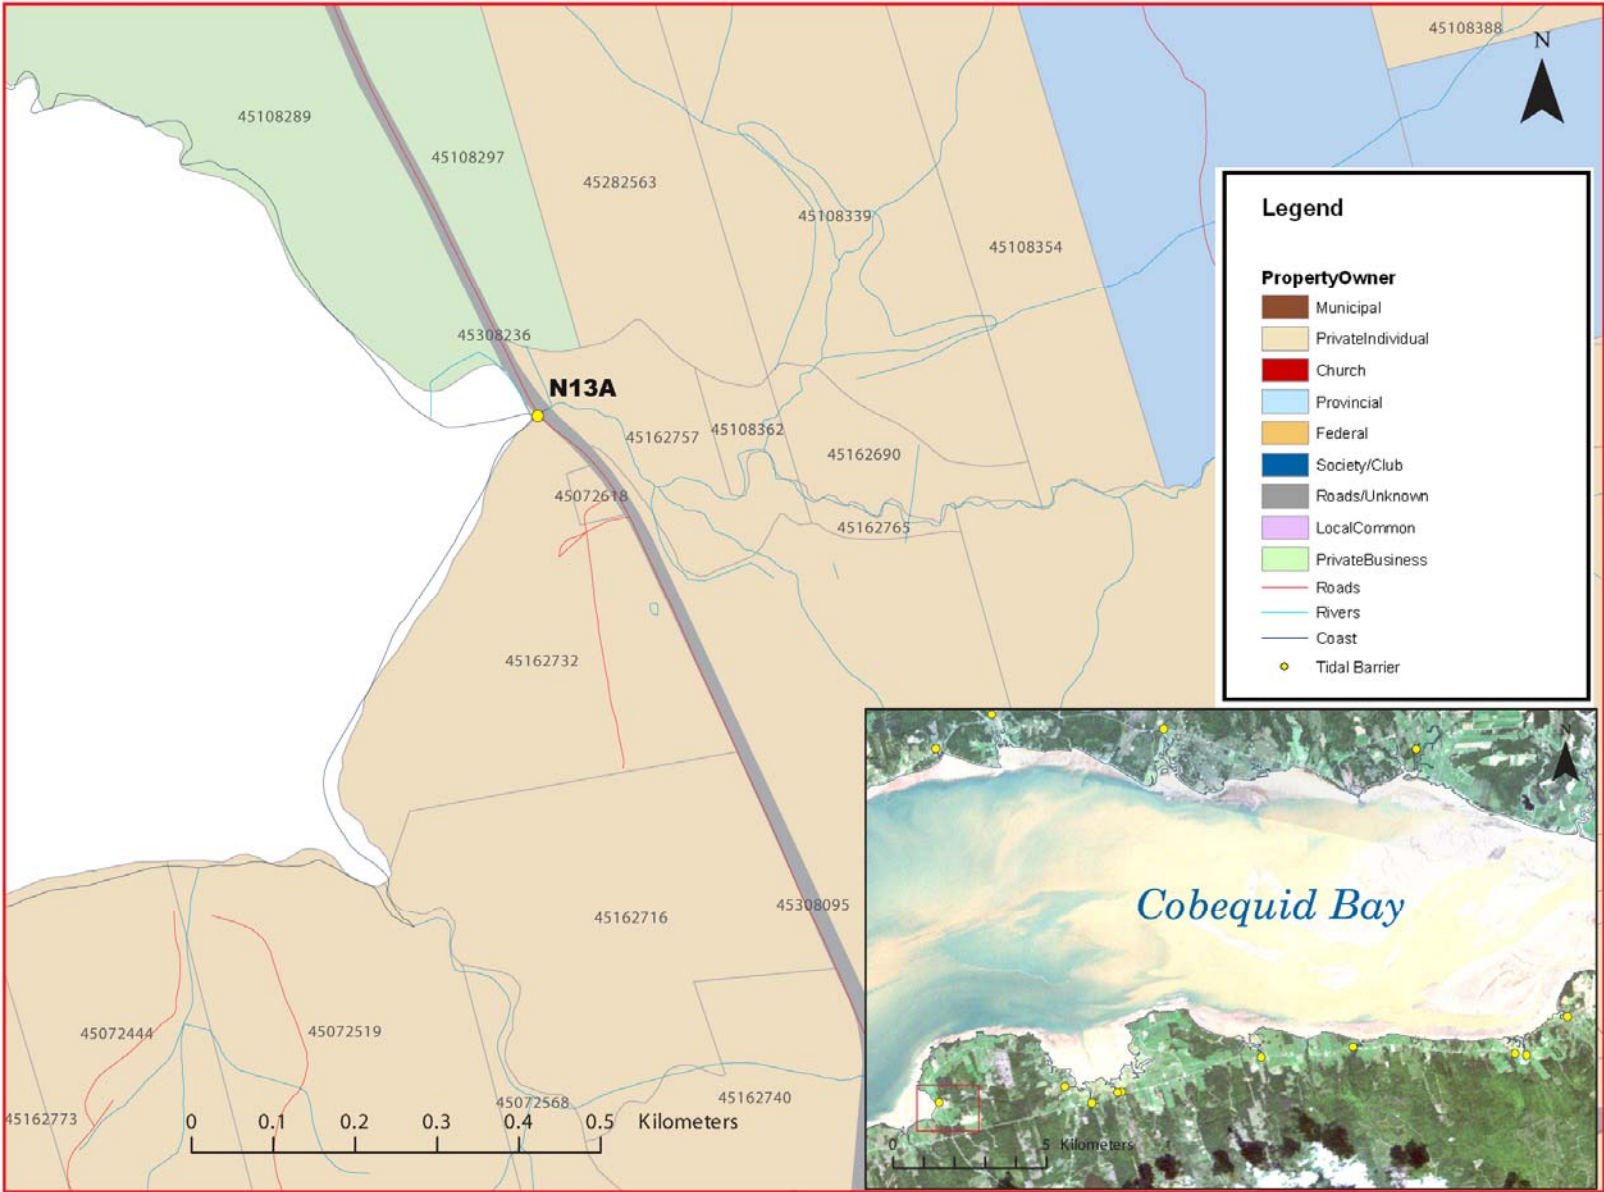
Figure 1: Property management and tidal barrier data for Nova Scotia (Service Nova Scotia, and Municipal Relations)
