**Site N20C:** Mill Brook

**Road Crossing:** Culvert (concrete)

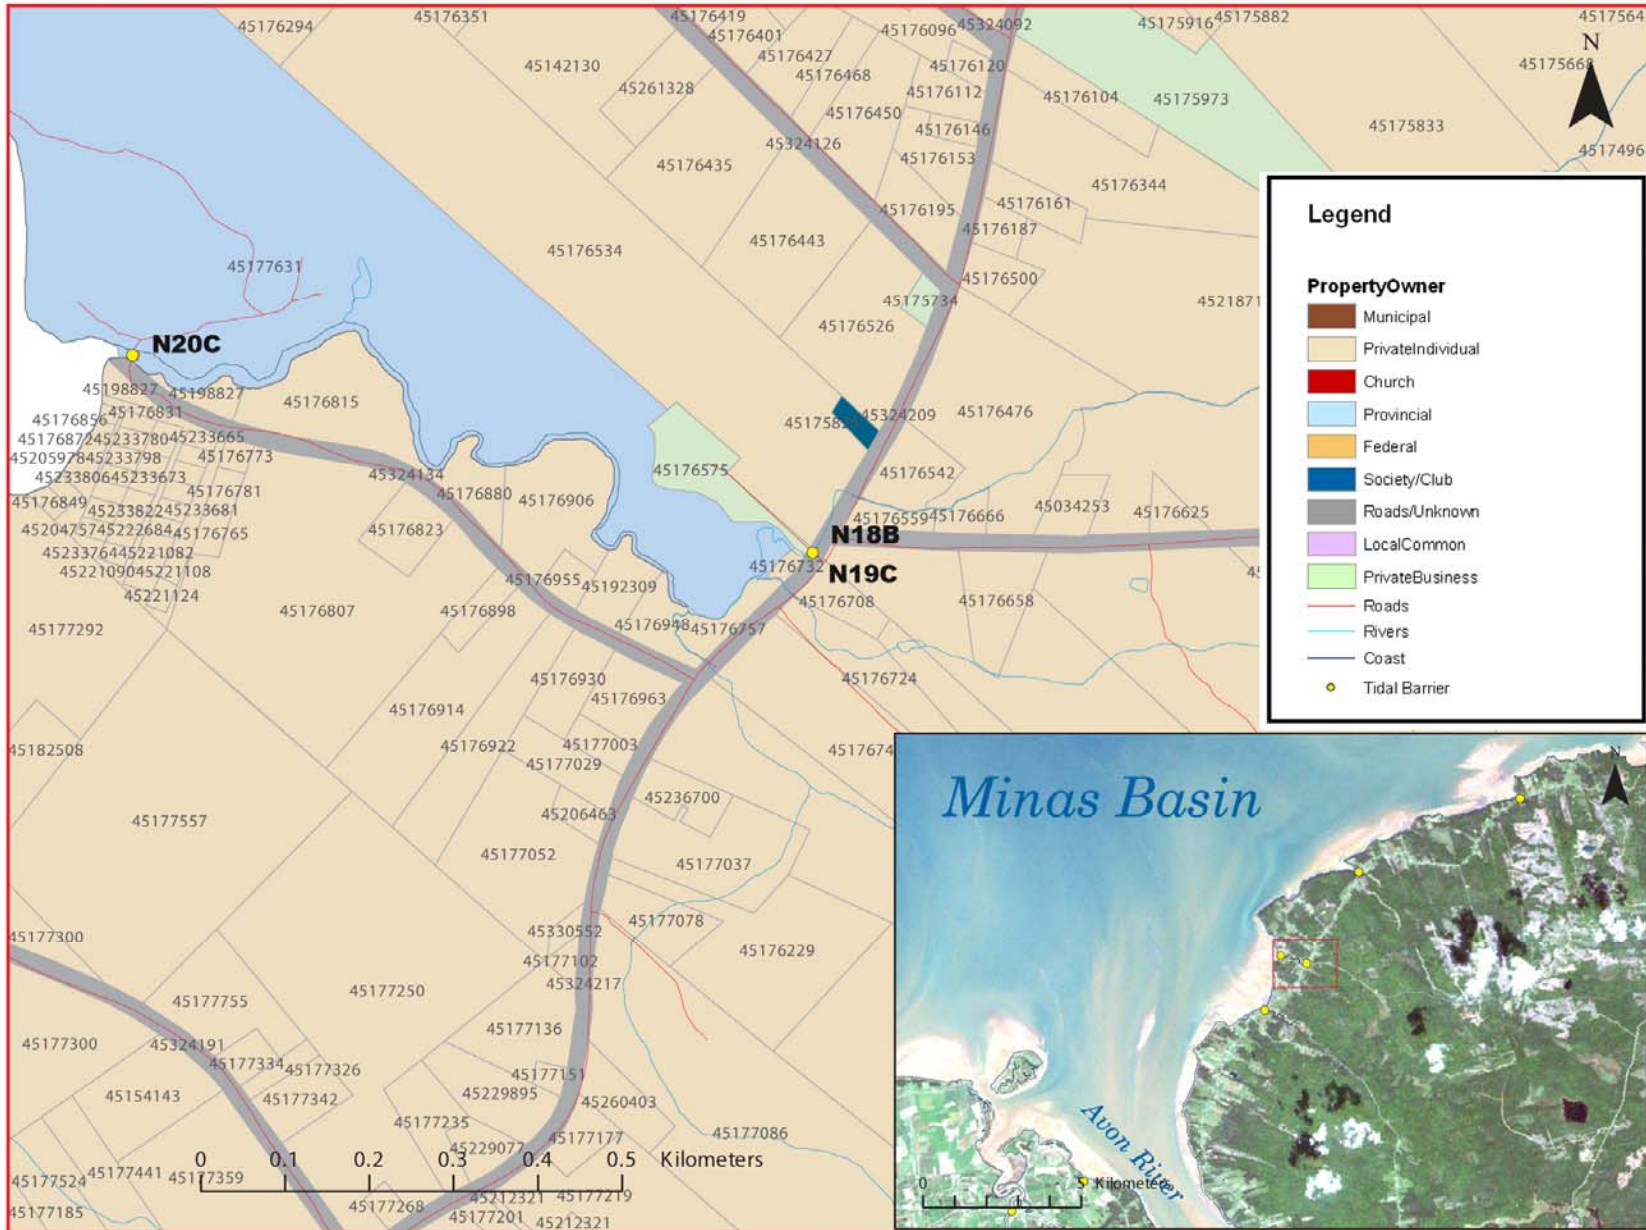
**Figure 1: Property management and tidal barrier data for Nova Scotia (Service Nova Scotia, and Municipal Relations)**
