Site N2A: Five Mile River

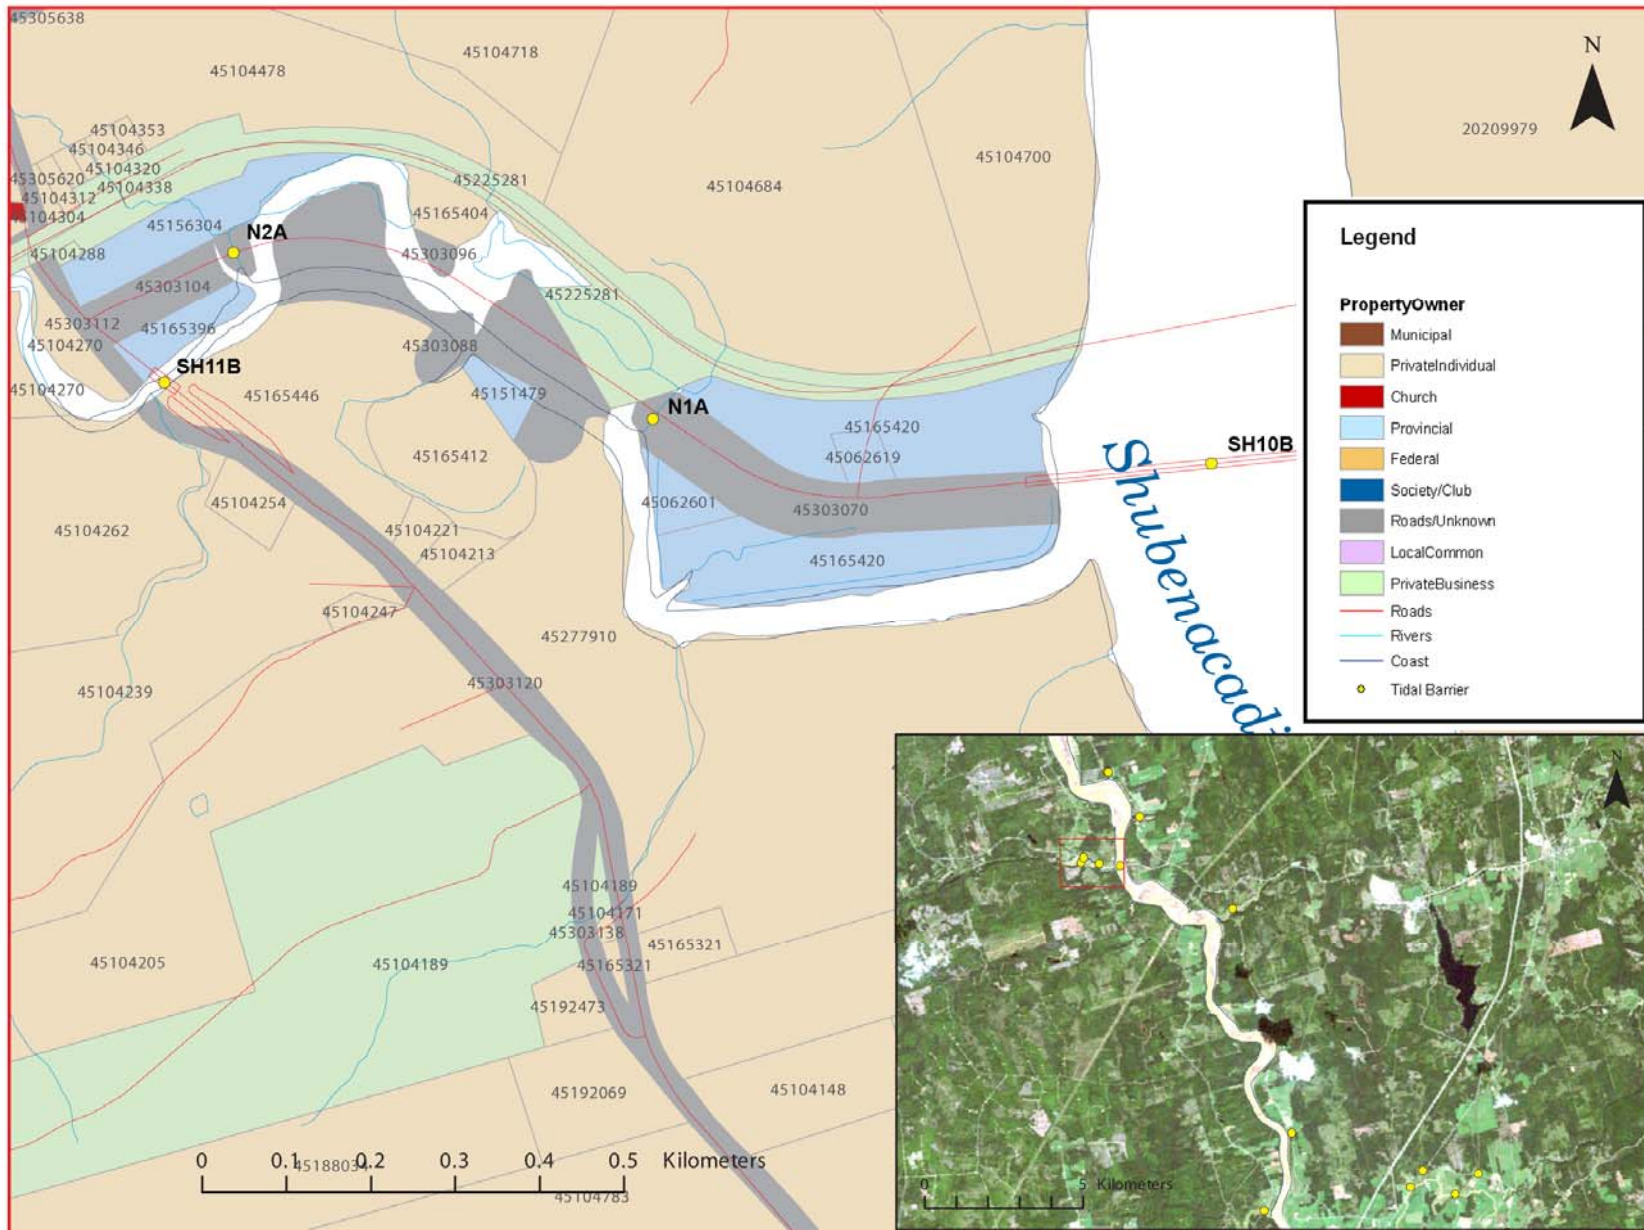
Figure 1:
Property management and tidal barrier data for Nova Scotia (Service Nova Scotia, and Municipal Relations)
